Manhole Inspection Summary

Manhole # S37KK_021MH

Insp Date: **3/19/07 10:39 AM**

Location Address: **423 NORTH AVE**

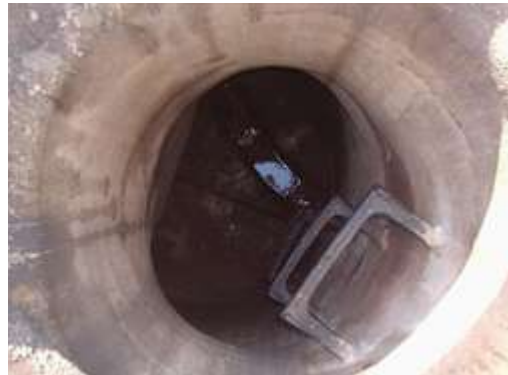
Top View

Barrel infiltration. Bench debris.

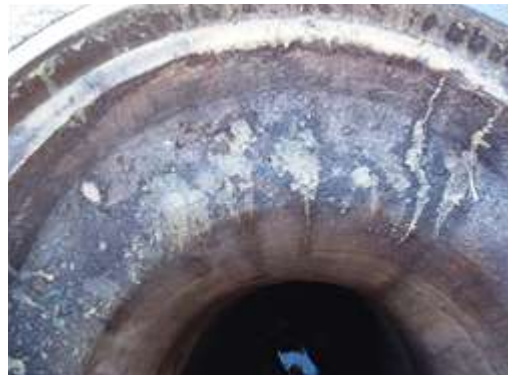
Defect

Frame leaks. Frame offset. Adjustment and Barrel infiltration.

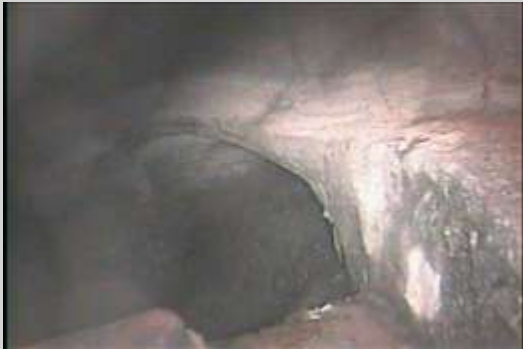
27 in. Circular Gravity Sewer Pipe Out @ 12 O'Clock

Invert Depth: **11.82** (ft.) Flow Characteristics: **Fast**

Infiltration: **Evidence** Pipe Seal Cond: **Unknown**

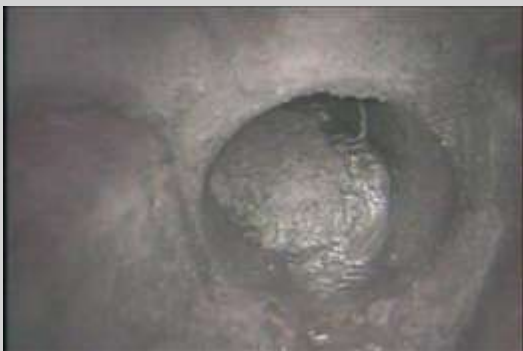
8 in. Circular Gravity Sewer Pipe In @ 3 O'Clock

Deposits: ☐ None ☒ **Mud** ☐ Sludge ☒ **Debris** ☐ Grease

Silt Depth: **4** (in.) Deposits Extent: **Medium**

Infiltration: **None** Pipe Seal Cond: **Roots**

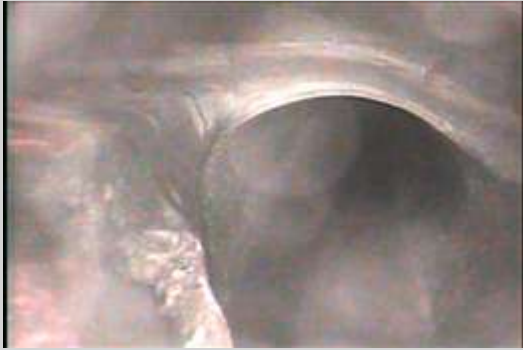
27 in. Circular Gravity Sewer

Invert Depth: **11.76** (ft.) Flow Characteristics: **Fast**

Infiltration: **None**
